HONEYWELL INC HOPKINS MN DEFENSE SYSTEMS DIV
XM587E2/XM724 ELECTRONIC TIME FUZES SYSTEM VERIFICATION TEST PH--ETC(U)
JAN 78 J C RAVIS

HDL-CR-78-157-1

JANUARY 1978

Prepared by
HONEYWELL INC.
DEFENSE SYSTEMS DIVISION
600 SECOND STREET NE
HOPKINS, MINNESOTA 55343

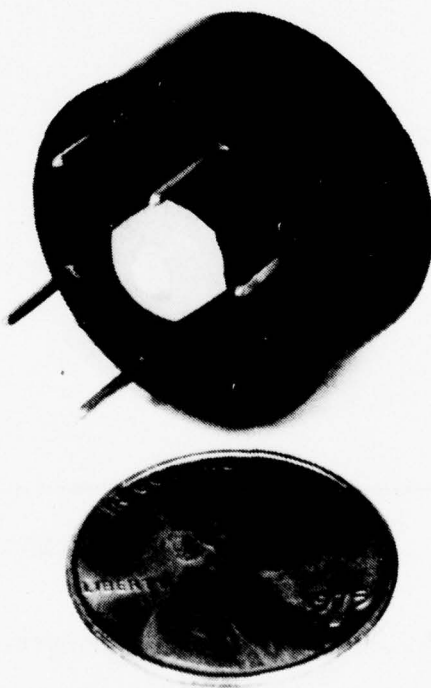
Figure 5. Power converter transformer.

The other problem was miswiring of the transformer because of the numerous leads. Since the power converter operation depends on proper transformer phasing, miswiring caused nonoperation.

The solution to both of these problems was to modularize the transformer with keyed output/input pins to preclude improper wiring and encapsulate the module in the proper encapsulant material. In addition, test requirements were developed to ensure that all transformers were tested for turns ratio and output phasing.

The new power converter transformer package is shown in figure 5. Fifteen units were fabricated to check out the assembly process. The units were tested per the test requirements, and 13 units were encapsulated and retested. One unit was tested for repeatability, with the results as shown in table I. In addition, two of the transformers that were encapsulated were subjected to shock per MIL-STD-883, method 2002.1, condition G. The shock level used is shown in figure 6. It will be noted that the shock level was approximately 1,000 g's less than the 30,000 g's required. This was due to setup and is not indicative of capability. Both transformers passed the test requirements after shock; the post-shock data are contained in table I.

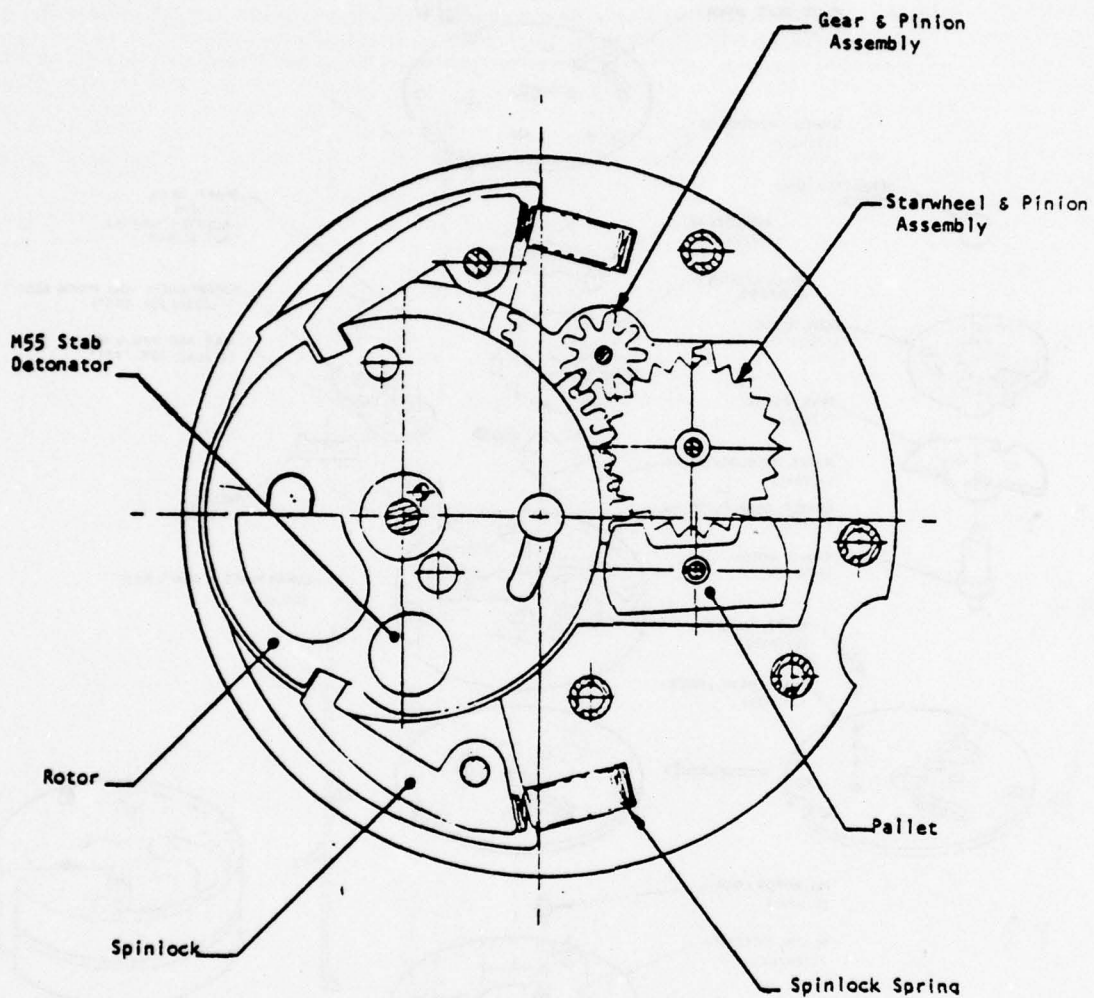
Figure 7. Rotor and gear train of the S&A module of the XM587E2/XM724 fuzes.

. The motion of the rotor is damped by a runaway escapement, resulting in an arming delay or safe separation distance. The torque produced by the rotor must therefore be transmitted through the gear train. If an impact such as from in-bore balloting forces occurs on the upper left hand portion of the S&A module, as viewed in figure 8, then the resulting impulse (or shock) will also tend to drive the rotor toward the armed position and will apply a shock loading to the gear train. In 175mm gun firings at zone 3, this impulsive side load may be several times as severe as the normal operating load of the gear train.

Die-cast zinc, of which the SVT vintage gear-and-pinion assemblies were made, is very sensitive to impact loads at temperatures below room temperature. In fact, due to the existence of a crystalline structure transition temperature, the impact energy required to break a die-cast zinc test specimen at -40°F may be as low as 5 percent of the room temperature value. This does not mean that die-cast zinc is not a suitable material for use in S&A device gear trains; it does mean that conservative designs must be used to allow for the cold temperature impact sensitivity.

The corrective action taken was to replace the die-cast zinc gear with one machined from wrought aluminum, which does not go through a crystalline transition. This aluminum gear is staked onto a one-piece machined pinion and shaft and, in construction, is similar to what is used in the M732 and M577 fuzes, the M125 booster, and the safety adapter for the M564/M565 fuzes. The functional form of this new assembly is identical to the die-cast zinc version. Laboratory tests were performed to confirm that the new machined gear set is

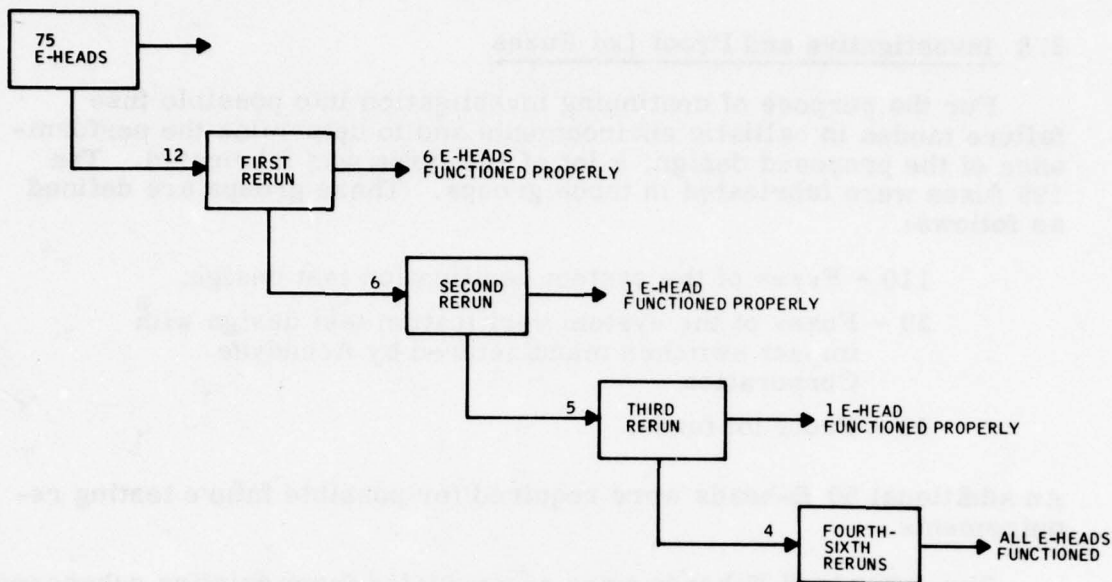
Figure 16. Impact switch test results

In addition to the in-process failures, only about 80 percent of the electronics (encapsulated) passed the required point detonating lot sample test. The test was repeated on all units which failed, and some had been rerun up to six times before they functioned. The exact cause of this problem is unknown, but the impact switch was suspected since prior failure analysis on this device indicated foreign material inside the switch housing. A summary of point detonating switch testing is shown in figure 16.

Functional testing and failure analysis of switches supplied by the manufacturer of the first article acceptance sample impact switches (Kaupp) confirmed that the problem was one of problem with the Kaupp switches. The failure analysis report on the impact switches is contained in appendix A.

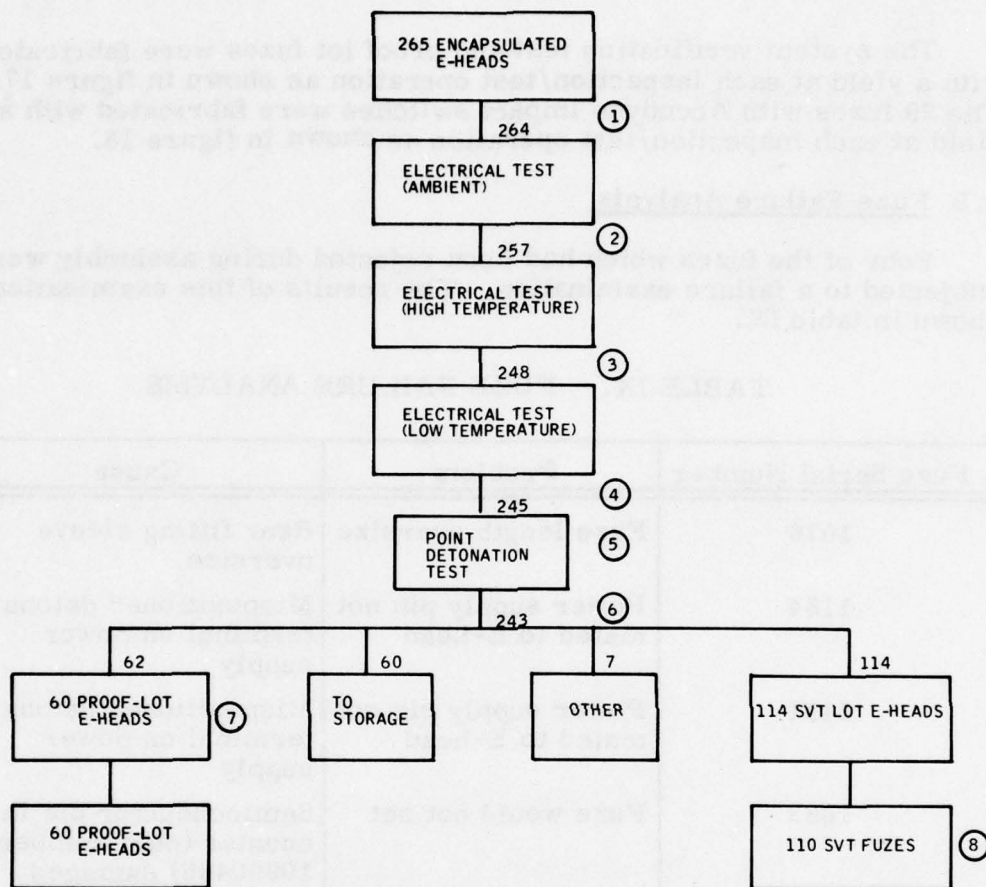
Figure 17. Flow diagram, fuze yield data
(Kaupp impact switches).

- ① ONE E-HEAD WAS LOST DURING THE STAKING AND POTTING PROCESS
- ② SEVEN E-HEADS WERE REJECTED AT ROOM AMBIENT TEMPERATURE BY THE AUTOMATIC TESTER. HOWEVER, FOUR OF THEM MAY BE ACCEPTED ON A WAIVER FOR TEST 1-5 (B).
- ③ NINE E-HEADS WERE REJECTED DURING HIGH TEMPERATURE TESTING.
- ④ THREE E-HEADS WERE REJECTED DURING LOW TEMPERATURE TESTING.
- ⑤ 241 E-HEADS WERE SUBJECTED TO THE PD TESTING. 75 FAILED THE TEST. ONLY 10 OF THE 241 E-HEADS WERE REQUIRED TO PASS THE PD TEST.
- ⑥ TWO E-HEADS WERE REJECTED DURING POST PD TEST INSPECTION, ONE WITH A LOOSE ORIENTATION CUP AND ONE WITH A LOOSE CENTER PAD IN THE NOSE PLUS ASSEMBLY.
- ⑦ COIL CONTACTS WERE DAMAGED ON TWO E-HEADS DURING REWORK; i.e., MILLING OF A SLOT TO ACCOMMODATE THE ADDED EXTERNAL POWER SUPPLY WIRE.
- ⑧ FOUR FUZES WERE REJECTED AFTER CRIMPING; THREE WITH IMPROPERLY SEATED O-RINGS, AND THAT COULD NOT BE SET WITH THE FUZE SETTER.

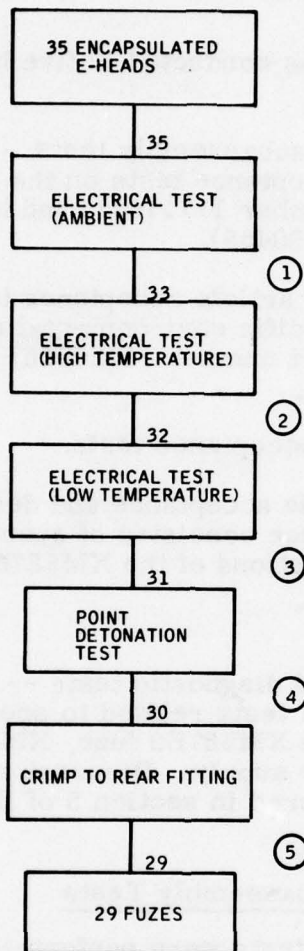
Figure 18. Flow diagram, fuze yield data (Accudyne impact switches).

- ① TWO E-HEADS WERE REJECTED FOR PARAMETRIC FAILURES DURING ROOM AMBIENT TEMPERATURE ELECTRICAL TESTING.
- ② ONE E-HEAD FAILED HIGH TEMPERATURE ELECTRICAL TESTING.
- ③ ONE E-HEAD FAILED LOW TEMPERATURE ELECTRICAL TESTING.
- ④ ONE E-HEAD FAILED PD TESTING, BUT PASSED THE POST PD ELECTRICAL TEST.
- ⑤ ONE FUZE WAS REJECTED AFTER THE CRIMPING OPERATION FOR EXCEEDING THE 3.76-INCH MAXIMUM DIMENSION.

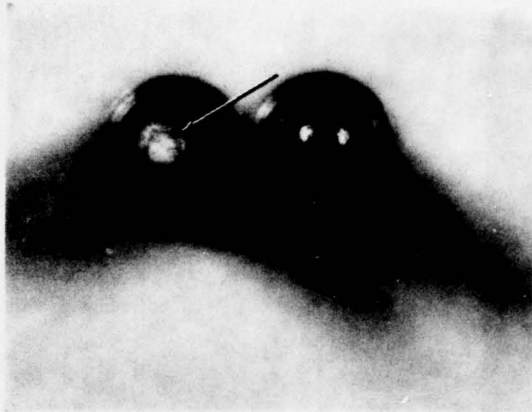
Photo 3 - 12X

Internal visual examination revealed organic contamination to some degree in all the Kaupp switches. The contamination was white in appearance and located in and on the contact cone. Contamination was also found on the spring and inside the switch housing. Those Kaupp switches which were intermittent during electrical testing revealed the largest amounts of contamination, specifically on the contact cone tip where the electrical connection is made (See Photo 3). The presence of the contamination prevented consistent switch closure. Attempts to remove the contamination by ultra-sonic cleaning with Freon were unsuccessful. Accudyne switches were free of contamination.

The contact cones from two Kaupp switches. The arrow indicates contamination on the tip of the cone for device #8. This switch malfunctioned 88.8% of the time. The remained cone is clean and did not malfunction.

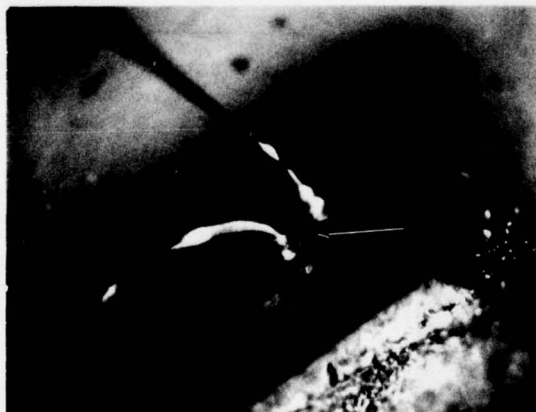
Photo 8 - Mag. 80X

Electrical tests indicated a start-up voltage of -4.0Vdc (S/B -6.50Vdc min). The device would not oscillate but tracked the D.C. input voltage. External visual examination revealed no failure related defects. Internal visual examination showed the cause of failure to be a lifted ball bond on the transistor Q4 emitter (see Photo 8).

The transistor Q4 emitter bond is lifted on oscillator SN 680.

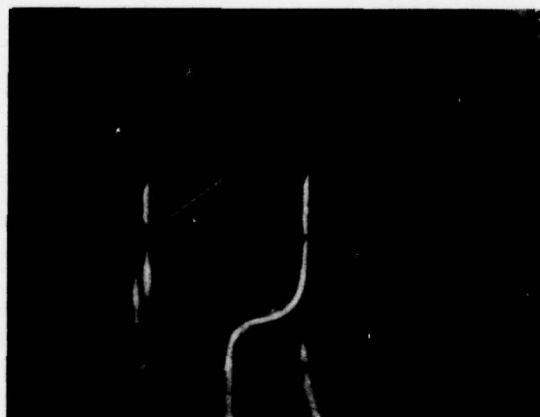
Photo 12 - Mag. 10X

Two small signal silicon NPN transistors were submitted. One of the two was known to be functional. The functional device was electrically tested and found to operate normally with $h_{FE}=196$. The second device was open circuited base to emitter and functional base to collector. External visual revealed the emitter lead to be loose in the epoxy encapsulation. A crack was evident in the epoxy near the emitter lead (see Photo 11). Decapsulation verified the emitter lead to be open (see Photos 12 and 13). The cracked epoxy encasement allowed sufficient movement of the external emitter lead to break the internal lead wire at the post bond heel.

Transistor 2N6010 after decapsulation. The arrow shows the area of the emitter lead break.

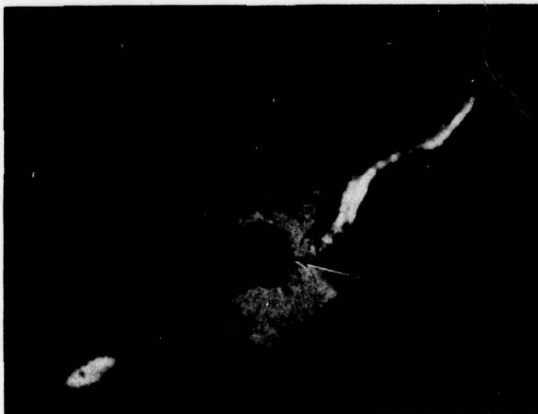
Photo 16 - Mag. 15X

One of six solid tantalum capacitors, C4, showed an intermittent open circuit during electrical testing. External visual examination revealed one external lead was loose (see Photo 15). Partial decapsulation showed the break to occur in the area of a void in the orange epoxy (see Photo 16). Handling combined with the weakened lead support caused by the epoxy void resulted in the open circuit.

Partial decapsulation
revealed a void in the
epoxy surrounding the
break in the capacitor
lead.

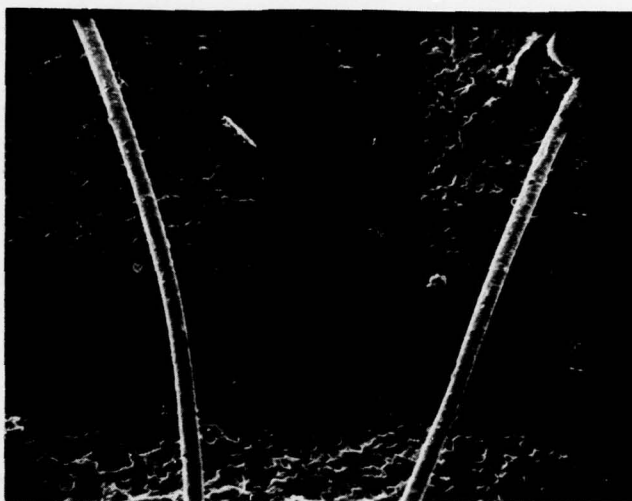
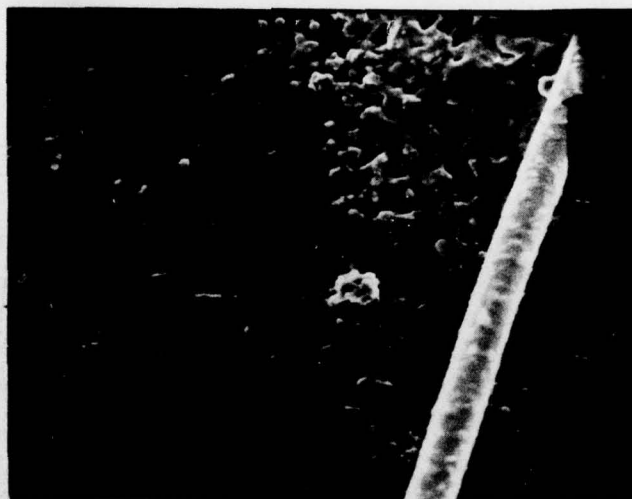
The hybrid was carbon coated to prevent charging during SEM analysis. Figures 1 through 4 show areas of dendrite formation which can be seen more readily by a light microscope than on the SEM. The x-ray map of Figure 3 clearly shows the silver dendrite shape. Figure 2 (secondary mode) shows the same area, but the photo must be studied carefully to see the dendrites as they are largely obscured by a residue film on the substrate. The sulfur distribution, Figure 4, shows a slight sulfur enhancement in the dendrite area, so that the dark visual appearance of the silver dendrites could be due to a sulfide layer.

FIGURE 1. Q3, area of dendrite formation between connector pads, dendrites are roughly under where the wires cross over the ceramics. 2. Q3. Detail of dendrites.

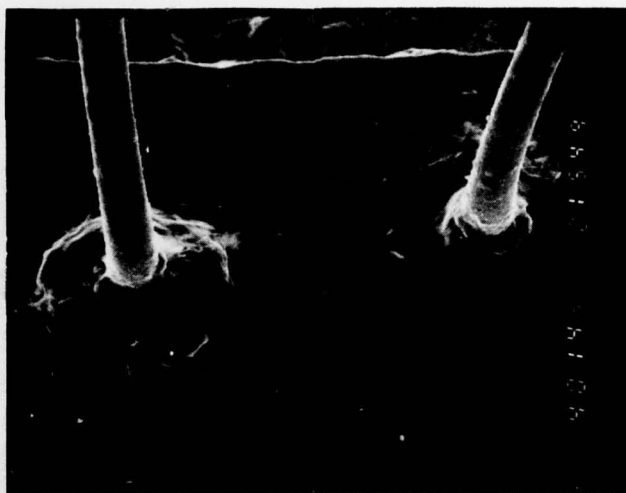
FIGURE 5. Q3, transistor with ball bonds. Some silicone coating still present, obscuring active area. 6. Q3, Map for silver on the area of Figure 5. There is some silver on the ball bonds and on the transistor in the center region.

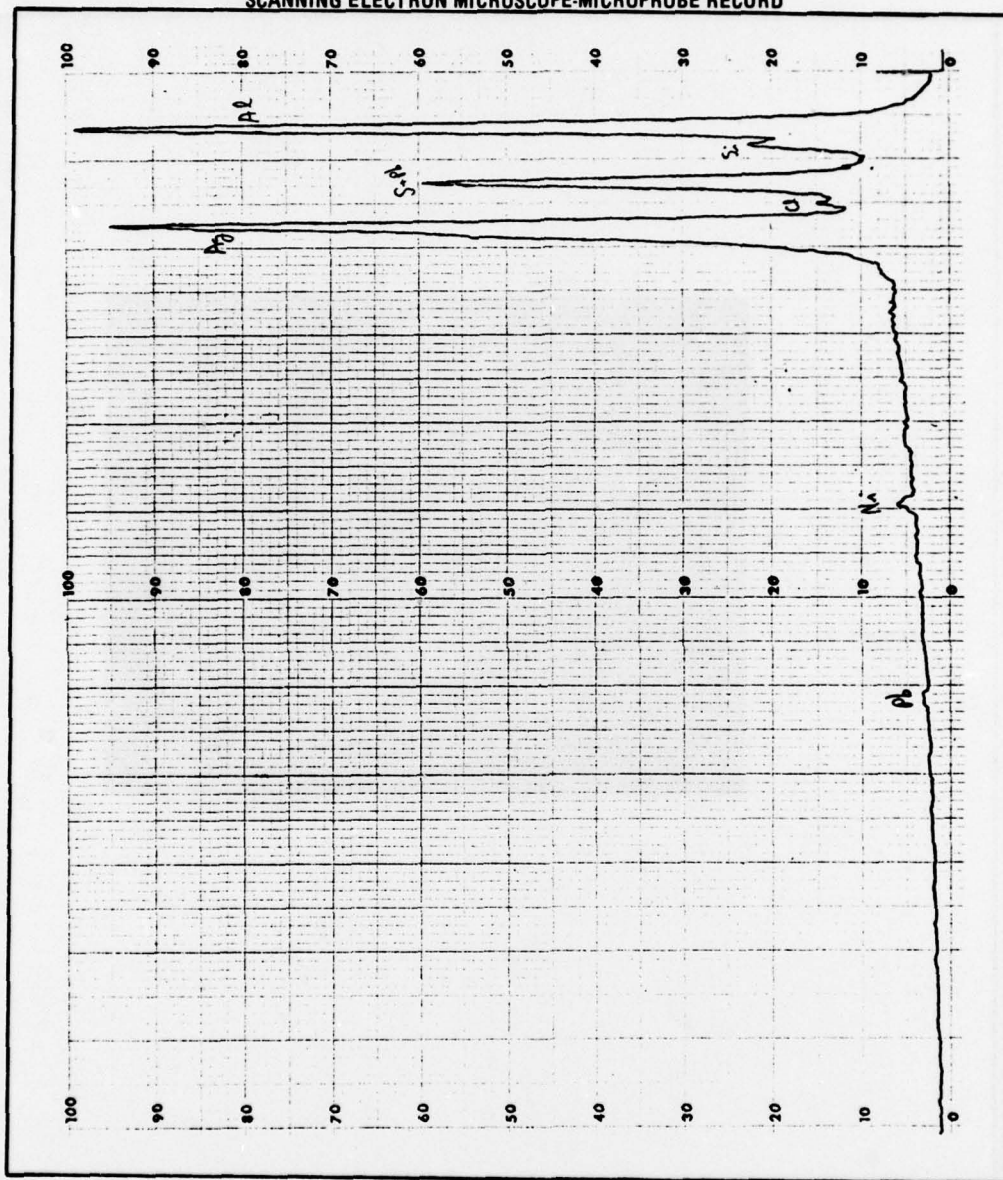
DEVICE/PART NO. XM-587 Hybrid CUSTOMER B. Goblisch
ENGINEER D.J. Hajicek MODE X-ray
FIGURE 8. Analysis of dendrite of Figure 2. 21KV.

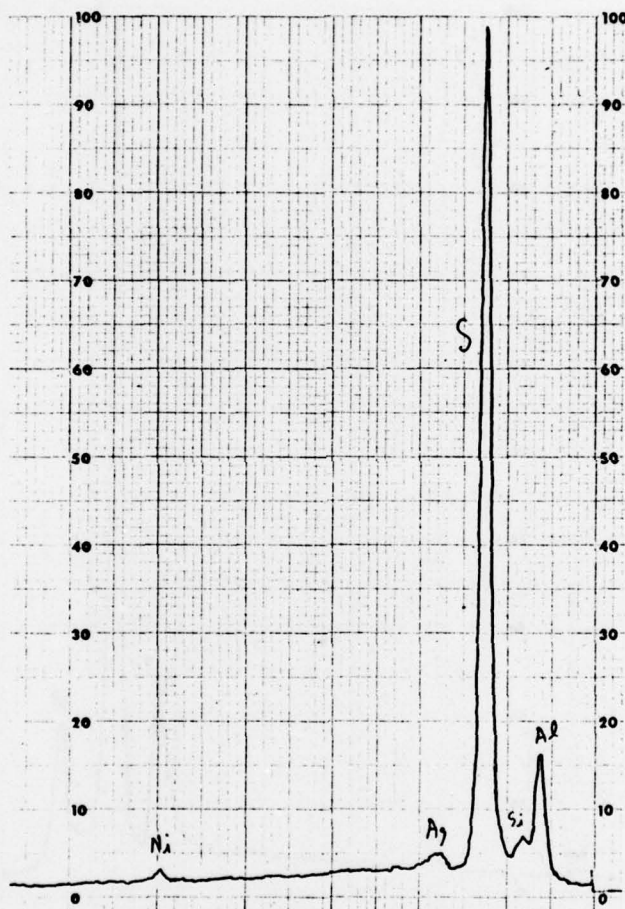
DEVICE/PART NO. XM-587 Hybrid CUSTOMER B. Goblisch
ENGINEER D.J. Hajicek MODE X-ray
FIGURE 9. Analysis of area A on Figure 5.

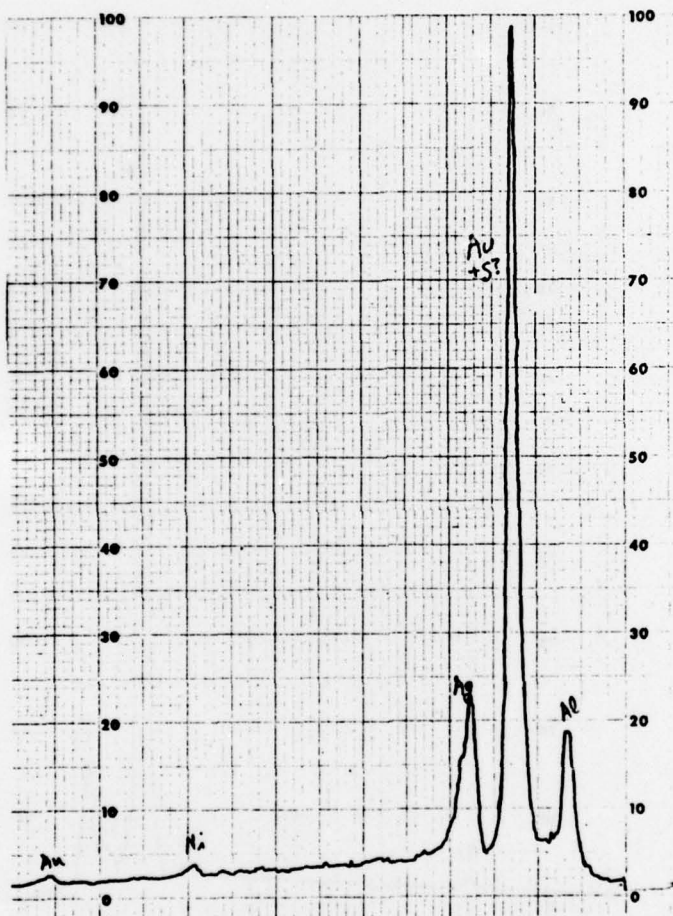
DEVICE/PART NO. XM-587 Hybrid CUSTOMER B. Goblisch
ENGINEER D.J. Hajcek MODE X-ray
FIGURE 10. Analysis of area B of Figure 5.

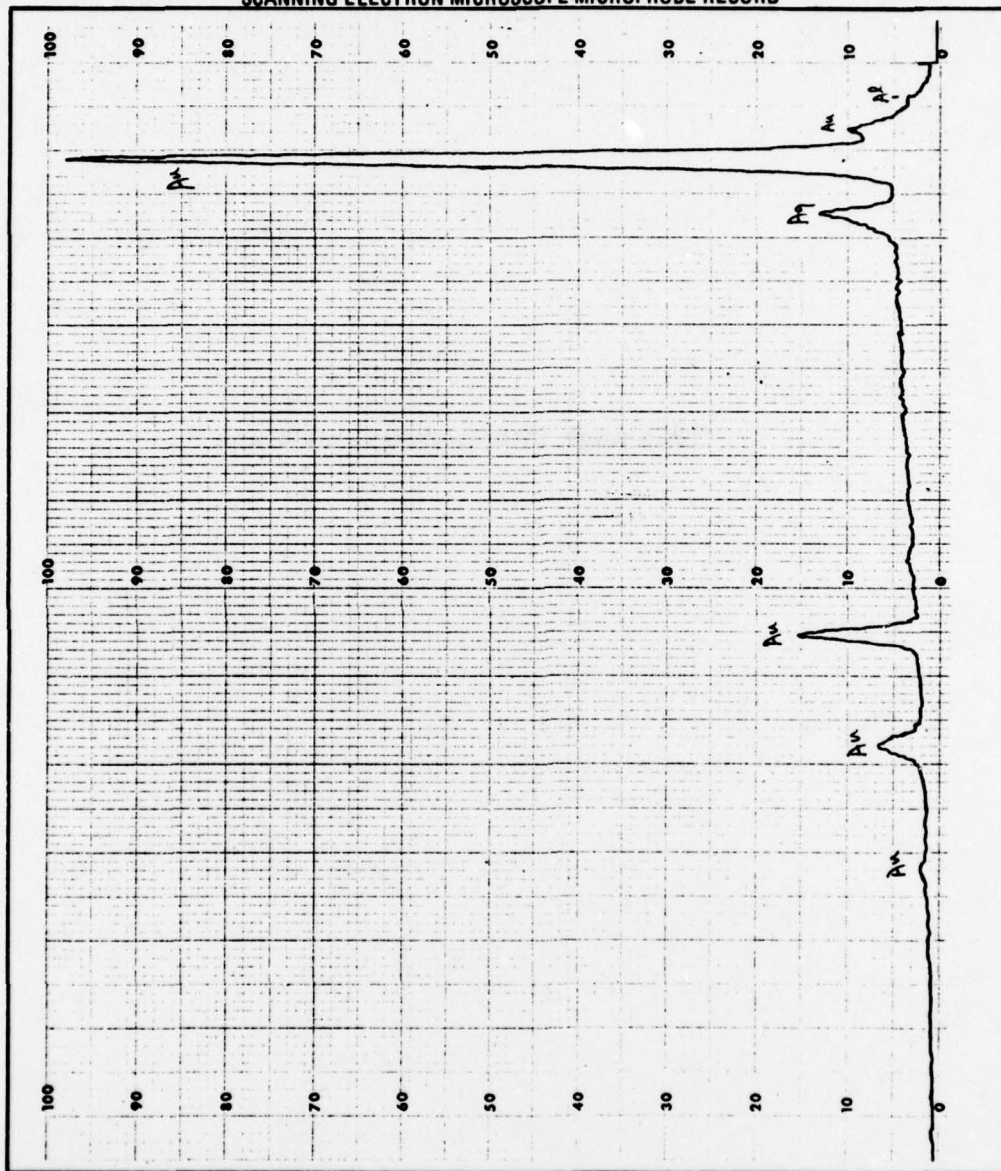
X-ray analysis of the discolored ball bond on Q2 (Figure 7), shows major gold (and possibly sulfur), minor silver and trace aluminum.

DEVICE/PART NO. XM-587 Hybrid CUSTOMER B. Goblish
ENGINEER D.J. Hajicek MODE X-ray
FIGURE 11. Analysis of ball bond.

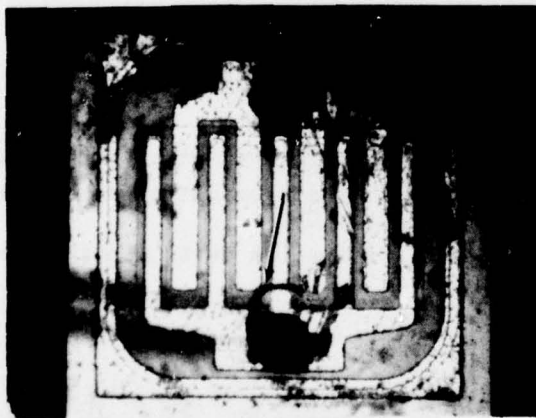
Figure 2 - Mag. 165X

Transistor Q6 die with
a metallization smear
across the P-N metalli-
zation. The smear
resulted from a mis-
placed ball bond.
